**P/N 80520-1**

SIZE: 45.65" in ID x 61.12" in length  
 SIZE: 1159.38 mm ID x 1552.32 mm length

The propellant tank is an assembly consisting of elliptical domes and a center section cylinder. The tank is mounted via mounting ring that is EB welded and located on the cylindrical portion of the propellant dome. The propellant dome contains both the inlet/pressurization and outlet/drain ports. The tank contains an internally-mounted propellant management device (PMD), with perforated sheet, fabricated to maintain separation of liquid fuel and gaseous pressurant, and to provide predictable gas-free liquid fuel expulsion from the tank under low or zero gravity conditions.

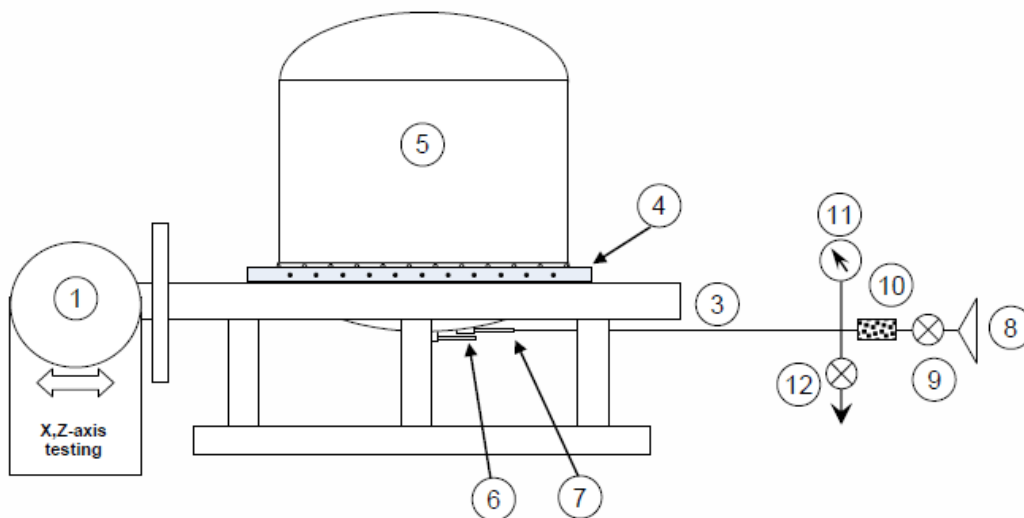
**Figure No. 8– Vibration Test**  
**Lateral Axis**  
**Sheet 1 of 5**

- |   |                            |    |                           |

| 1 | VIBRATION SHAKER | 7 | PRESSURANT PORT |
| 2 | DOES NOT APPLY | 8 | REGULATED NITROGEN SUPPLY |
| 3 | SLIP TABLE | 9 | INLET VALVE |
| 4 | RING ADAPTER 873-6954T-001 | 10 | FILTER |
| 5 | PROPELLANT TANK | 11 | PRESSURE GAUGE |
| 6 | PROPELLANT PORT, CAPPED | 12 | VENT VALVE |

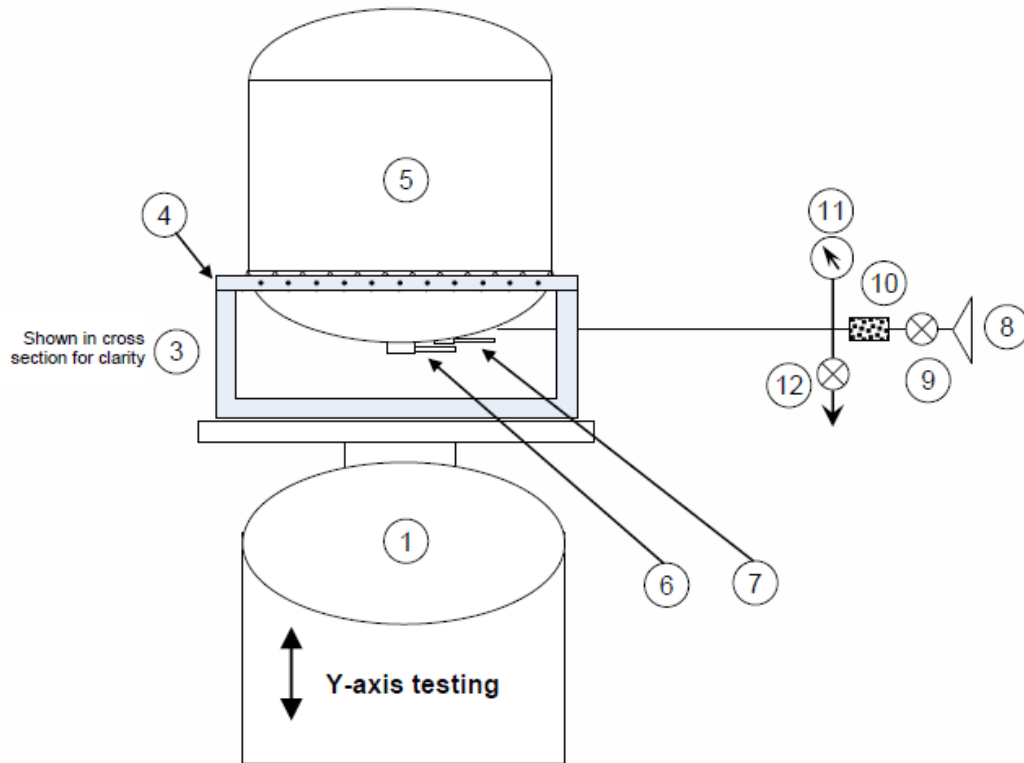
**Figure No. 8 – Vibration Test  
 Axial Axis  
 Sheet 2 of 5**

- |   |                                 |    |                           |

| 1 | VIBRATION SHAKER | 7 | PRESSURANT PORT |
| 2 | DOES NOT APPLY | 8 | REGULATED NITROGEN SUPPLY |
| 3 | VIBE FIXTURE TUB 873-6954R-002 | 9 | INLET VALVE |
| 4 | VIBE FIXTURE RING 873-6954T-001 | 10 | FILTER |
| 5 | PROPELLANT TANK | 11 | PRESSURE GAUGE |
| 6 | PROPELLANT PORT, CAPPED | 12 | VENT VALVE |

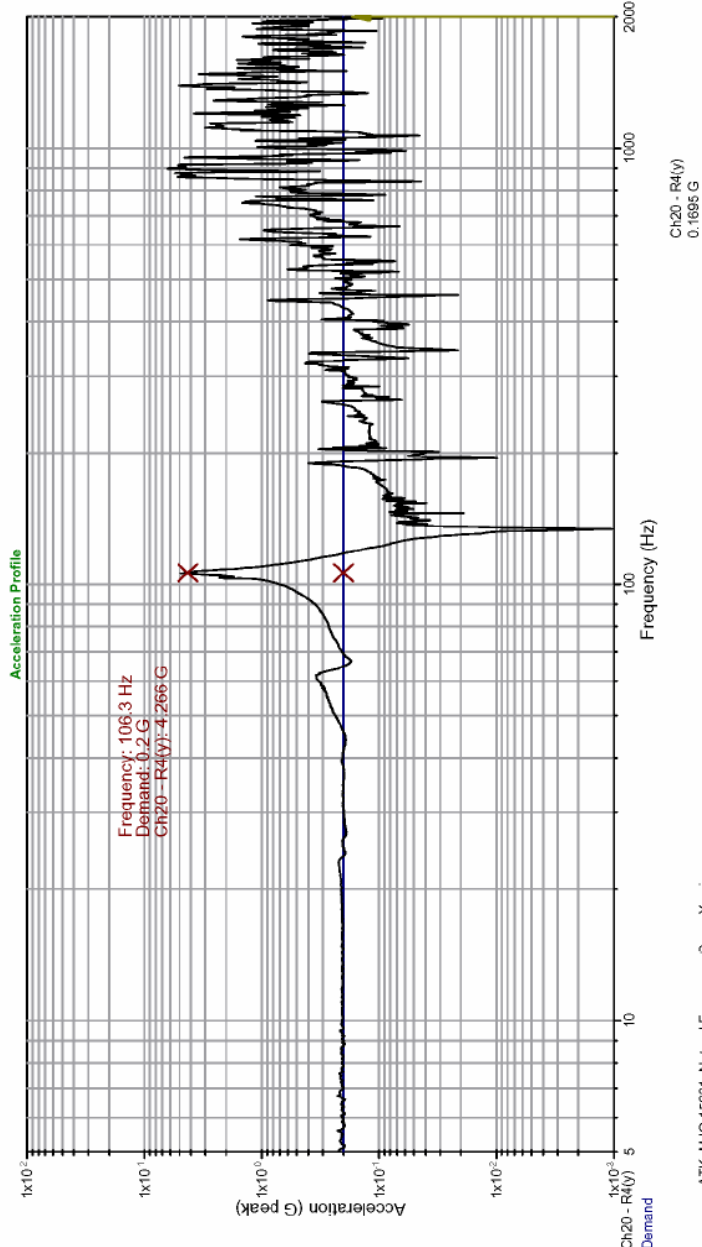
1 of 1 sweeps complete  
Sweep between 5 Hz and 2000 Hz at 2 Oct/min  
Elapsed Time: 0:04:28  
Current Frequency: 2000 Hz  
Points Per Sweep: 2000 points  
Mar 31, 2011 14:03:09

ATK\_MJO:15201, Natural Frequency Scan, Y-axis  
Propellant Tank, pn: 80520-11, sn: 0201, Plot #638

Natural Frequency			
Axis	Requirement	FEM Analysis Prediction	Actual Frequency
X	> 40 Hz	103.9 Hz	106 Hz
Y	> 40 Hz	103.9 Hz	106 Hz
Z	> 40 Hz	107.3 Hz	106 Hz

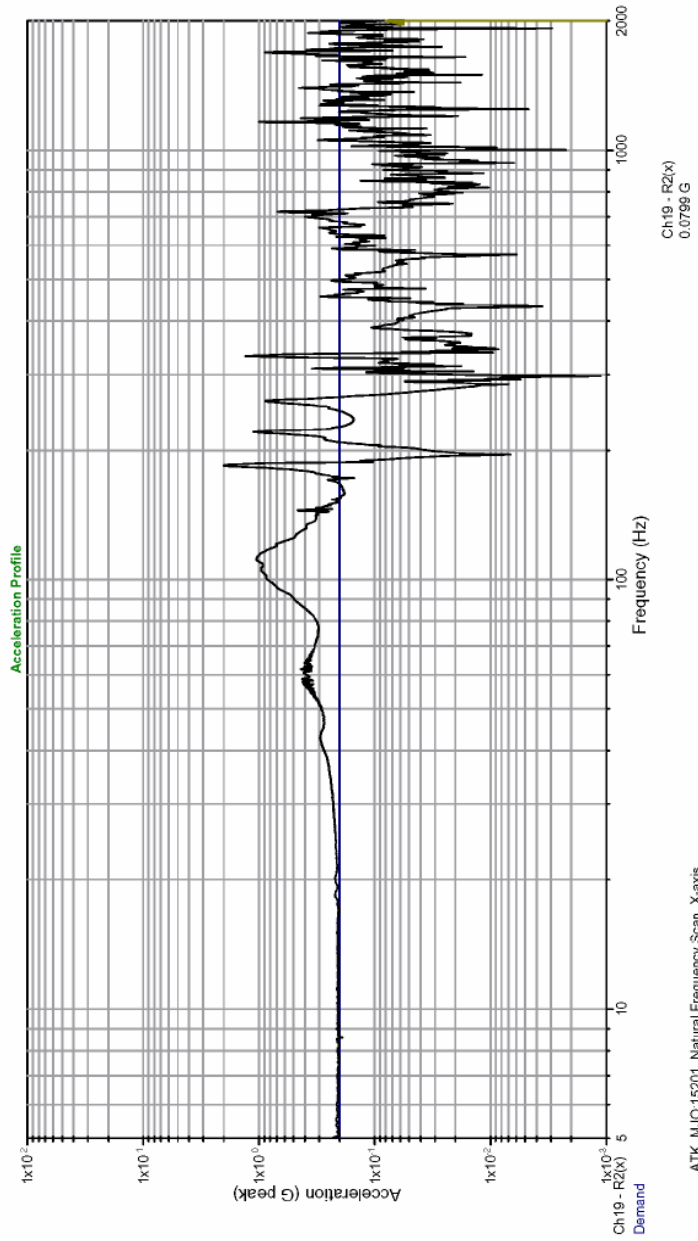
1 of 1 sweeps complete  
Sweep between 5 Hz and 2000 Hz at 2 Oct/min  
Elapsed Time: 0:04:20  
Current Frequency: 2000 Hz  
Mar 18, 2011 15:10:32  
Points Per Sweep: 2000 points

ATK\_MJO:15201, Natural Frequency Scan, X-axis  
Propellant Tank, pn: 80520-11, sn: 0201, Plot#335
